FIVE-YEAR REVIEW REPORT

First Five-Year Review Report
for

Presidio of Monterey Landfill
Monterey, California

September 2001

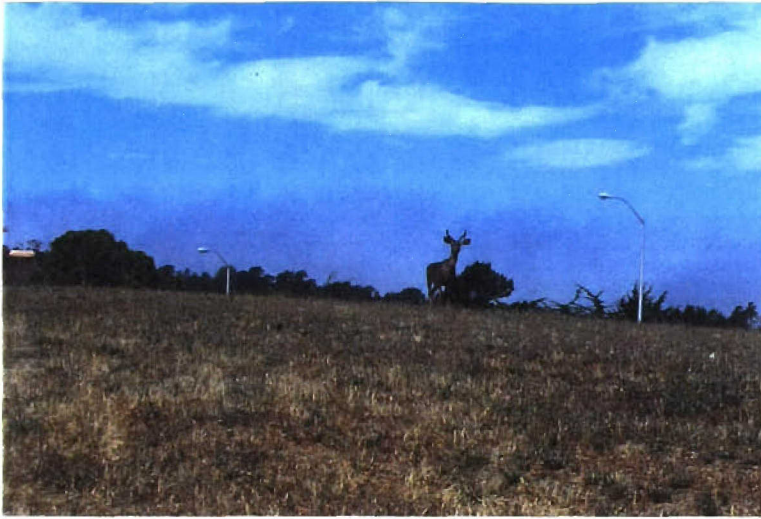
Photo taken from Ord Road looking NNW at lower cell

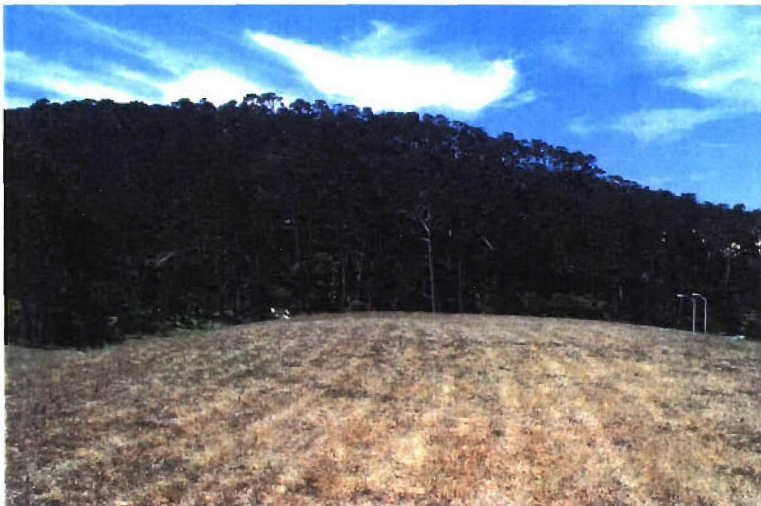
Photo taken on top of lower cell looking SSW

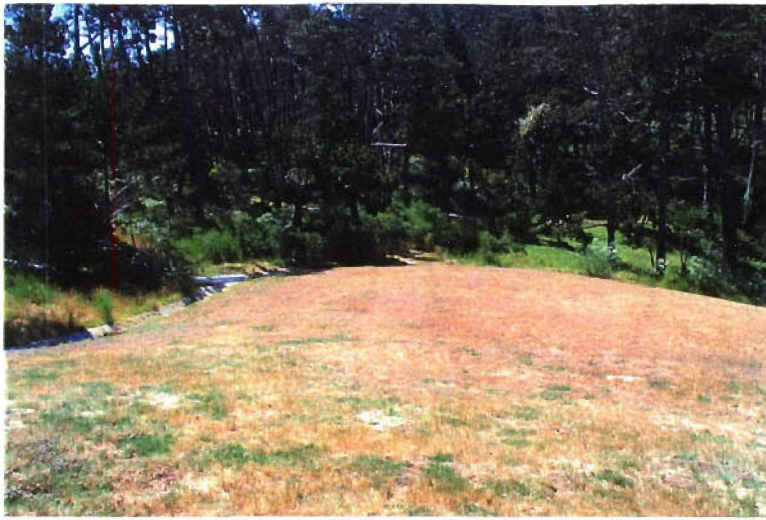
View of bottom half of lower cell looking South

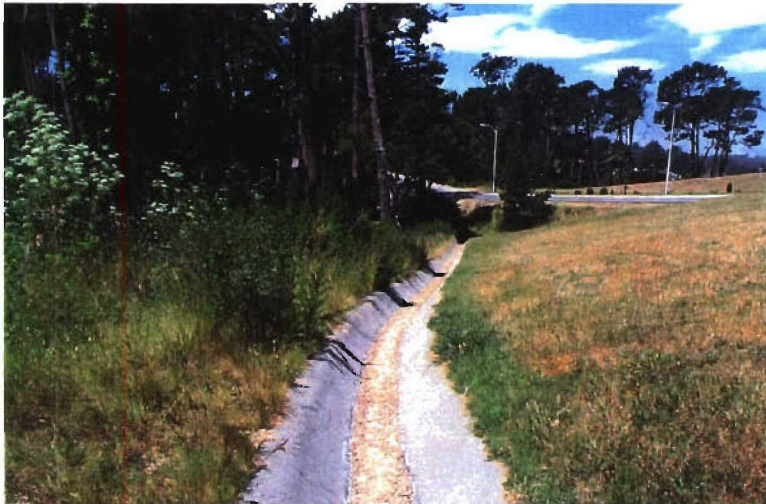
Photo taken of culvert on Southeast side of lower cell

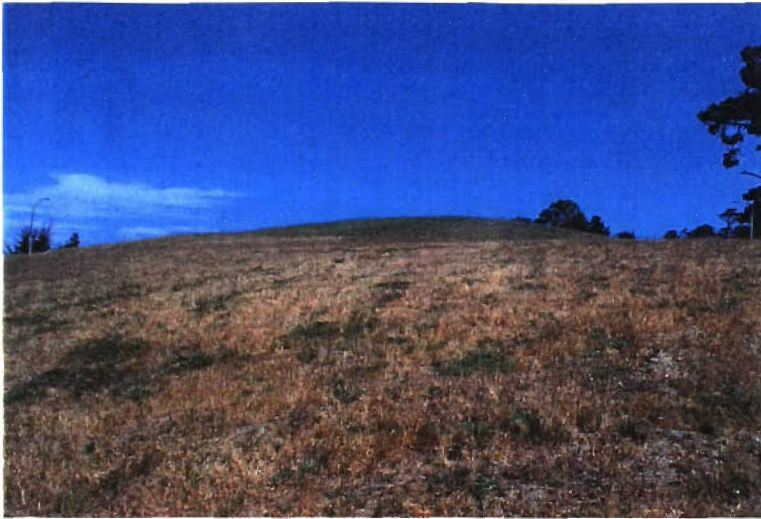
Photo looking from south to north in center of lower cell

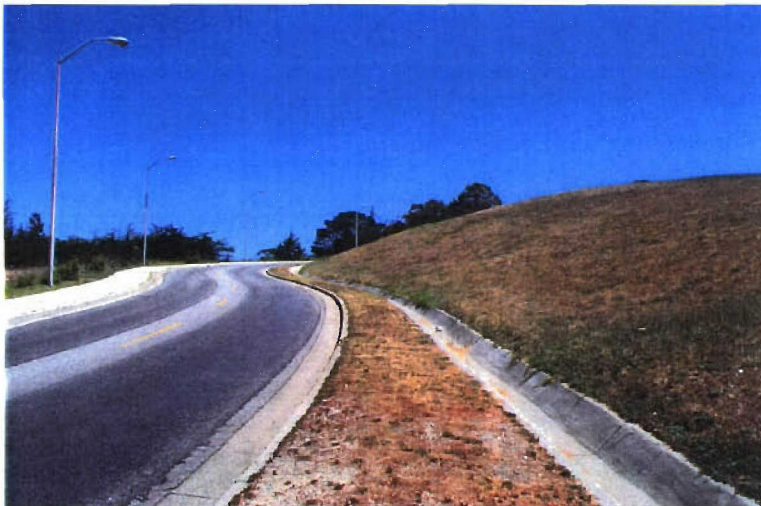
Mason Road looking north between both landfill cells

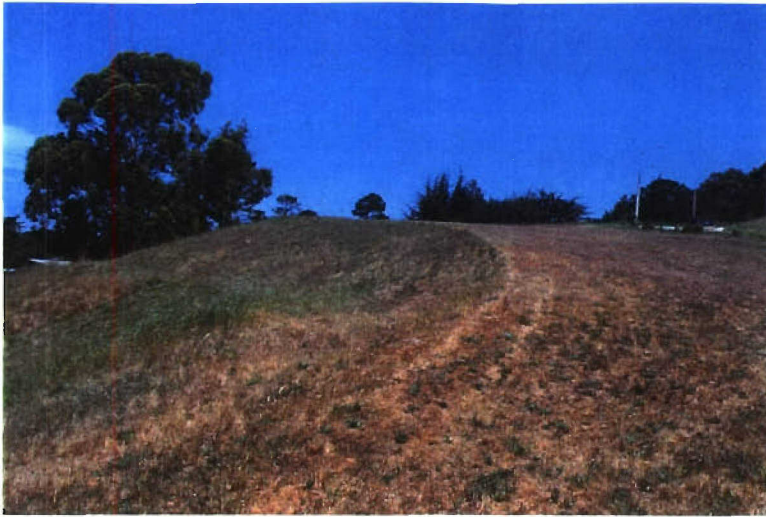
Photo of upper cell looking north

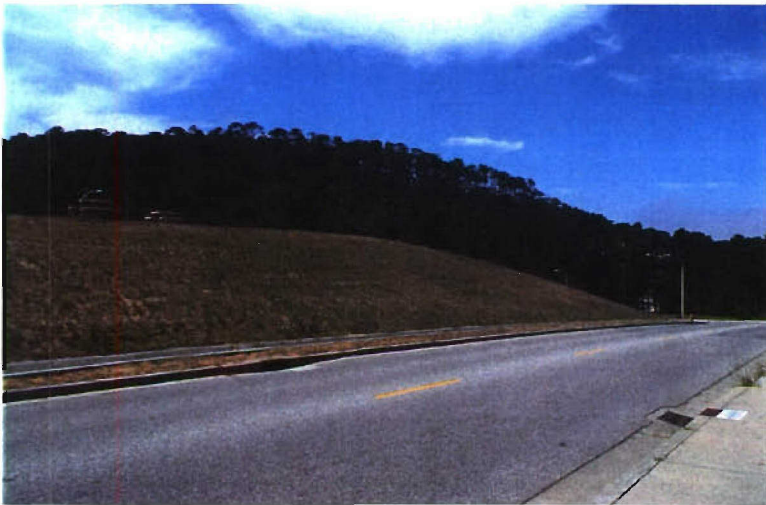
Mason road looking south at lower cell
